Emergency Stabilization & Rehabilitation Plan

# KNP Complex

Sequoia and Kings Canyon National Parks, CA

<b>Fire Name</b>	KNP Complex
<b>Fire Number</b>	CA-KNP-000124
<b>Fire Code</b>	N9UH
<b>Detection Date/Cause</b>	9/10/2021 /Lightning
<b>Date Contained</b>	N/A
<b>Acres</b>	Total Acres = 88,307 (as of 11/1/2021) Total Acres burned in SEKI = 78,675

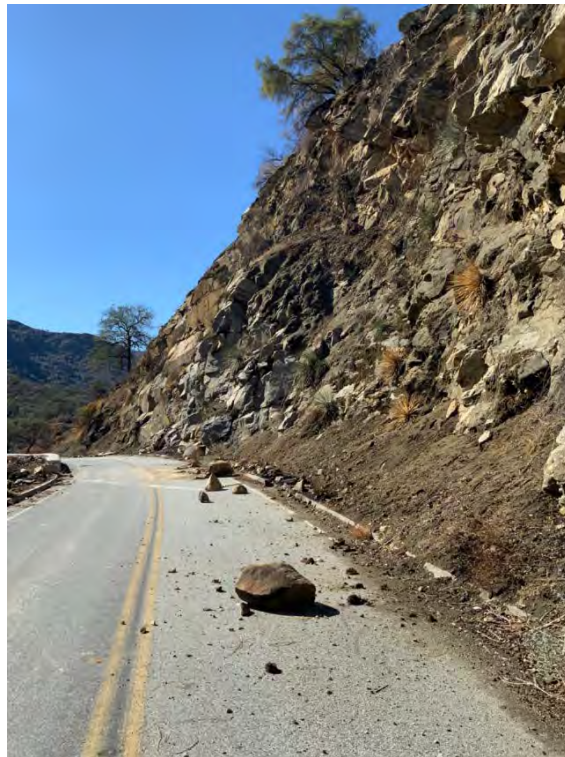
Similar, and perhaps even larger, rock falls are likely to occur throughout the winter as erosion of sediment dislodges loose rocks. Rock falls are most likely to occur during or immediately after storm events but could happen at other times. Over multi-year timescales, additional rockfalls are likely to occur as larger storms impose greater stresses and as the root networks of burned vegetation that are presently stabilizing loose rocks decay.

*Rock falls onto the Generals Highway from a roadcut between Ash Mountain and Hospital Rock following a rain event.*

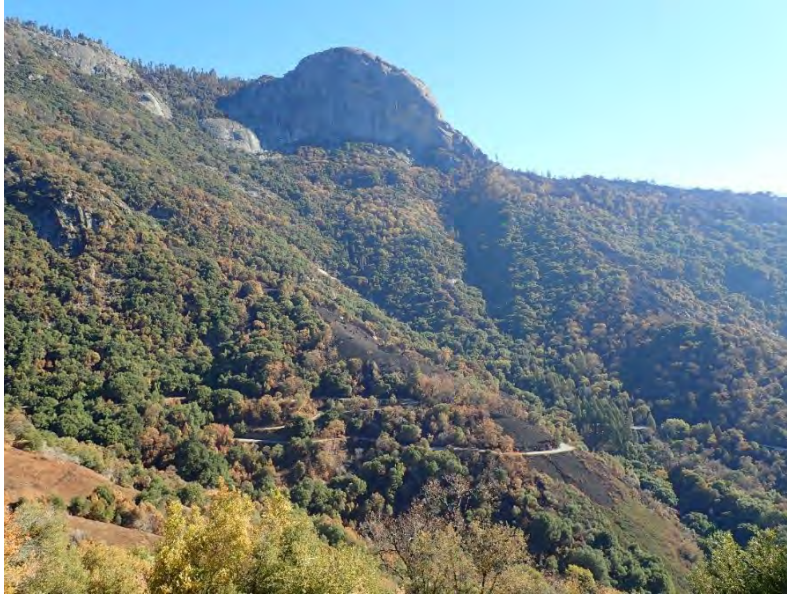
The General's Highway between Hospital Rock and the Crystal Cave Road junction switchbacks up very steep slopes with relatively high potential for rock falls. Fortunately, most of these slopes have low or even unburned SBS, reducing the potential for substantial post-fire rock fall activity. However, there are some patches of moderate and even high SBS above the General's Highway, notably on the ridge projecting south of Moro Rock; rock falls originating from this area could travel through areas of low or unburned SBS to impact the road.

*Unburned and low soil burn severity with patches of moderate and high soil burn severity above the General's Highway between Hospital Rock and Amphitheater Point.*

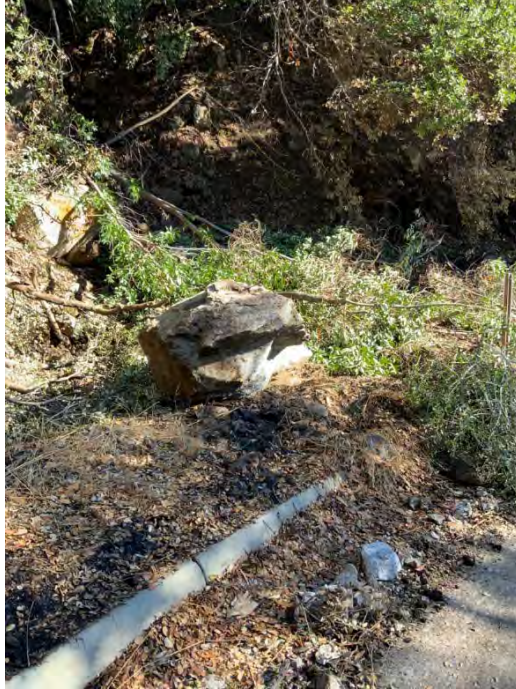
Rock falls of this magnitude and smaller are likely to occur throughout the winter in conjunction with winter storms; the potential for rock falls during clear summer weather is less likely but still possible.

*Boulder resulting from a post-fire rock fall from above the General's Highway above Amphitheater Point. A fragment of this boulder continued downward, damaging the asphalt in the uphill lane and traveling across a switchback to the next road segment below.*

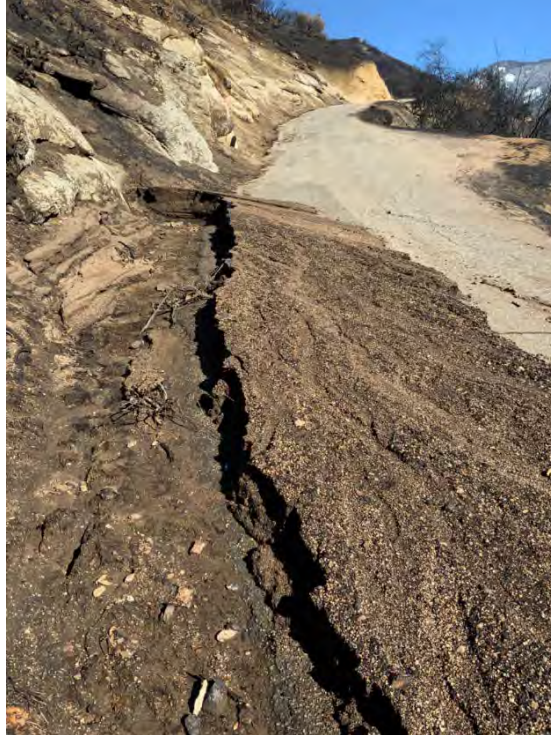
The Mineral King Road runs through the southern border of the KNP Complex. The road was evaluated for condition of culverts and susceptibility to sedimentation and debris flows. The slopes above and below the road varied from unburned to high SBS. Visual observations were made after a rain event indicating rilling in slopes with moderate to high SBS, undercutting of downspouts of culverts, sedimentation and blockage in culvert inlets, and sediment accumulation on roadways from loose high to moderate SBS hillslopes. Most notably, the highest contribution to sediment deposition on roadways was from high to moderate SBS hillslopes without preexisting culverts.

*Sediment deposited on the Mineral King Road following a rain event within an area of locally moderate to high soil burn severity.*

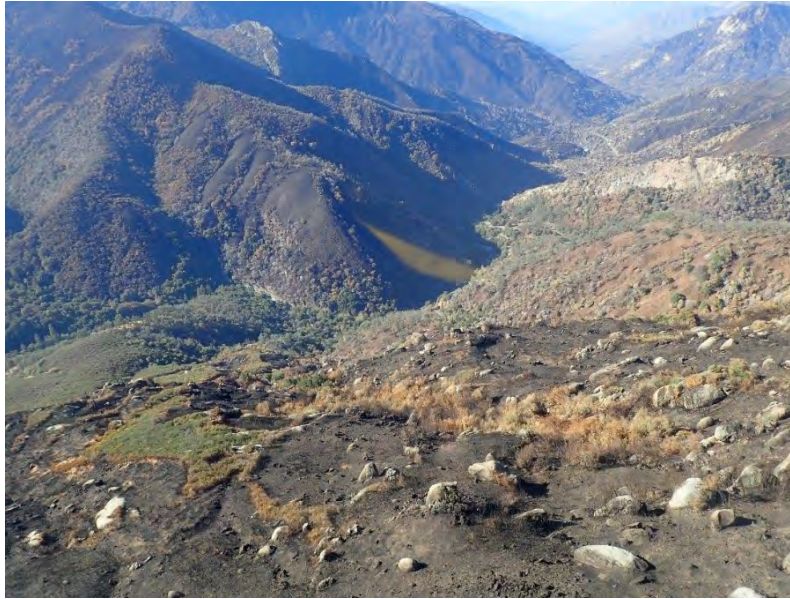
location, and runout paths of these boulders, it is possible that one or more of them could reach Buckeye Campground, posing risk to campers.

*Moderate to high soil burn severity on a hillslope north of the Middle Fork Kaweah River and east of the General's Highway below Moro Rock. Erosion of hillslope sediments could cause granitic boulders on the slope to tumble towards Buckeye Flat Campground, located in the unburned trees adjacent to the river at the toe of the slope.*

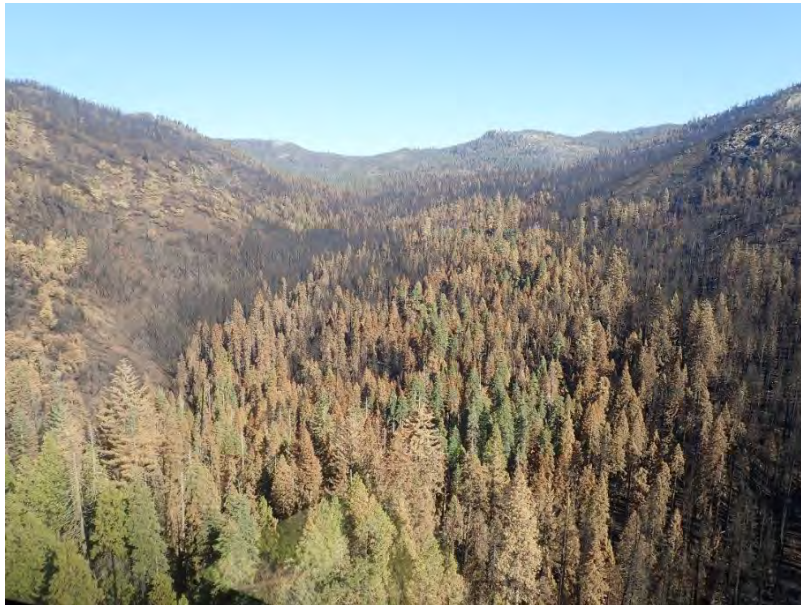
flows through the cave, which is how the extensive network of cave passages formed. At present the inlet sink where Redwood Creek enters Lilburn Cave is diffuse, i.e., the creek sinks into gravel over a length of channel rather than into an open cave entrance. The resulting sieving effect will likely help to prevent substantial coarse debris from entering the cave during storm-triggered events. However, finer sediment and high-water flows are expected to impact the cave during storm events, threatening cave resources and posing human risk.

*View looking north up Redwood Canyon from a position approximately above Lilburn Cave showing moderate to high soil burn severity above the cave and on the hillslopes adjacent to it. Sediment from burned slopes could enter Lilburn Cave via Redwood Creek, which flows through the cave, or through tributaries that enter the cave through sinkholes.*

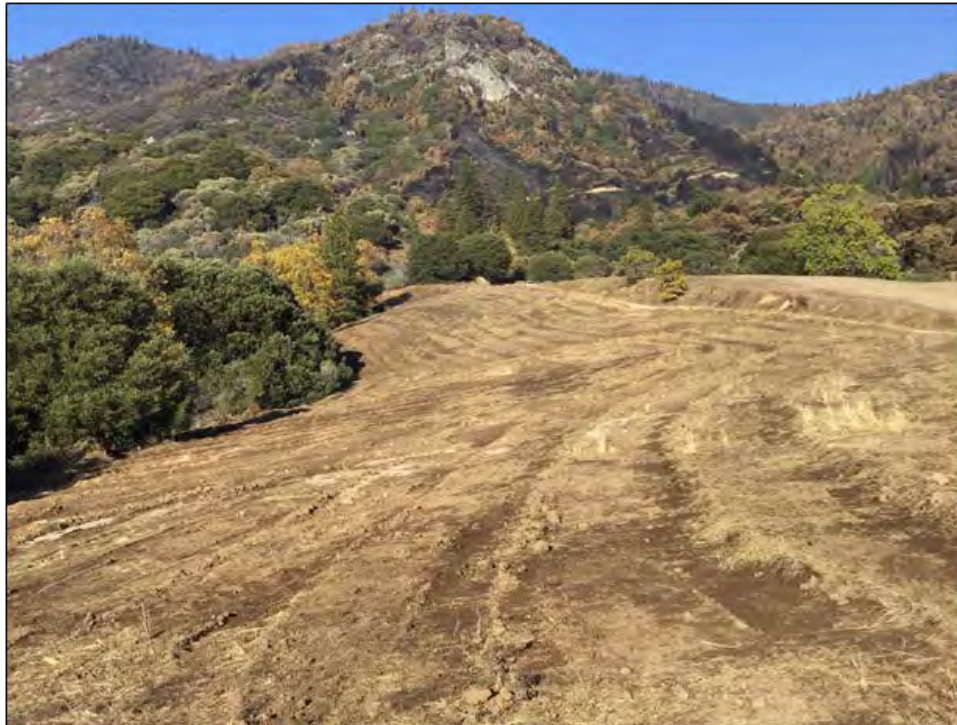
Fire suppression activities often include clearing burnable material from the soil surface to create fuel breaks, firefighter safety zones, or helicopter drop zones. The most dramatic examples of soil disturbance on the KNP Complex in SEKI were the large-scale disturbances created along Milk Ranch Road. Bulldozers cleared an approximately five-acre safety zone and constructed firelines averaging 75 feet wide (Figure 3). While suppression damage repair will restore some physical impacts, these areas are now primed for infestation by annual invasive grasses known to occupy adjacent foothill plant communities.

**Figure 3.** Large safety zone on Milk Ranch Road.

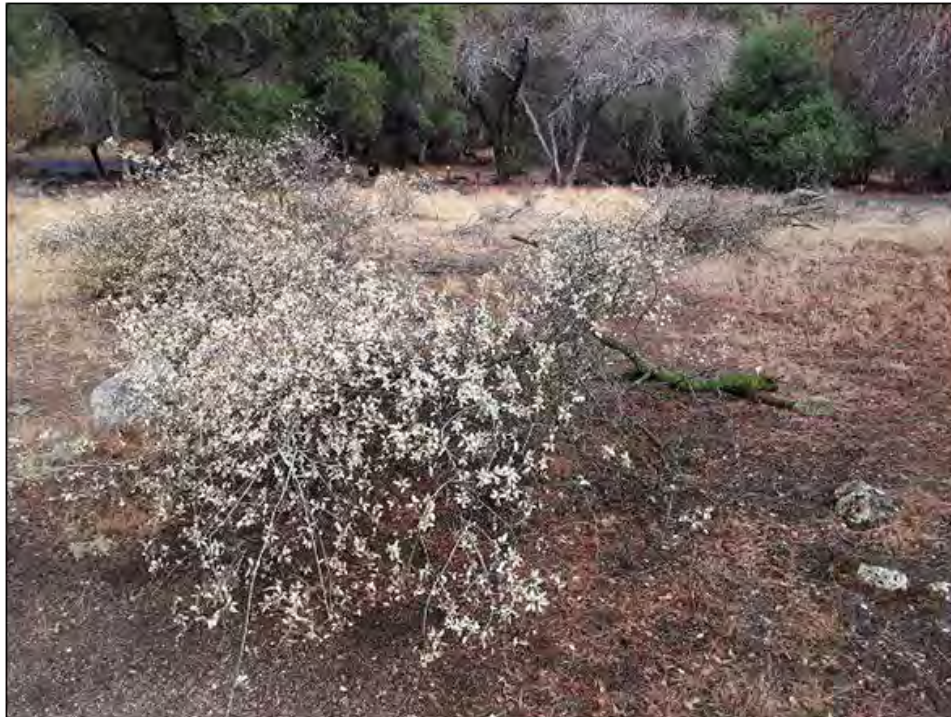
oak saplings were cut in an area of the campground that was planted 20 years ago to restore oak woodlands in that area (Figure 4). In Giant Forest, 10 to 15 sites with severely compacted soils due to previous building footprints were planted with mixed conifer forest species, including giant sequoia, to restore a mixed-age forest structure. Approximately 10 of these sites totaling about two acres, were burned in a burnout operation designed to protect the largest sequoias in the adjoining area. Most of the planted vegetation in the burned area was destroyed.

**Figure 4.** Twenty year-old blue oak that were planted to restore age diversity to the woodland at Potwisha Campground. These trees were cut as part of a fuel break project for the KNP Complex.

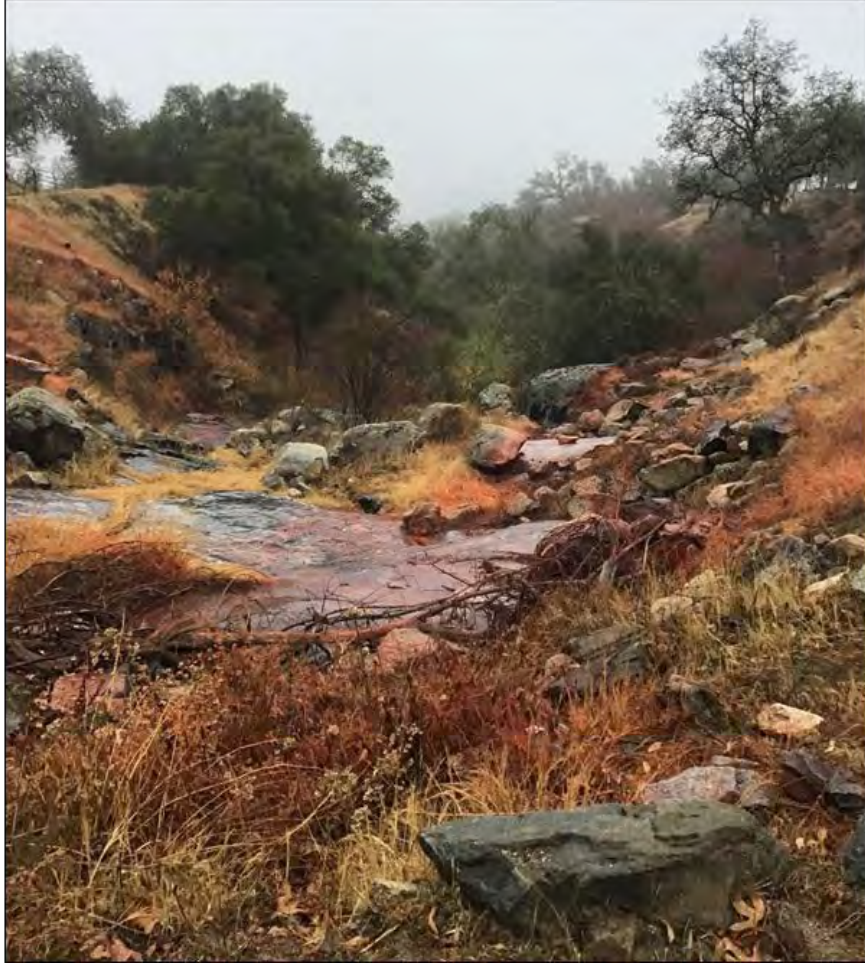
READ and BAER staff noted misapplied retardant in Sycamore Creek (Figure 5). Adjacent populations of *Iris munzii* were not directly affected. Amphibians known to occupy this drainagemay be affected as runoff transfers retardant throughout the stream. The KNP BAER Wildlife Assessment addresses this issue in greater detail. Invasive plants are less of an issue because retardant was applied in areas already heavily infested by invasive annual grasses.

**Figure 5.** Retardant impacts to Sycamore Creek. Newts and western pond turtle inhabit this drainage.

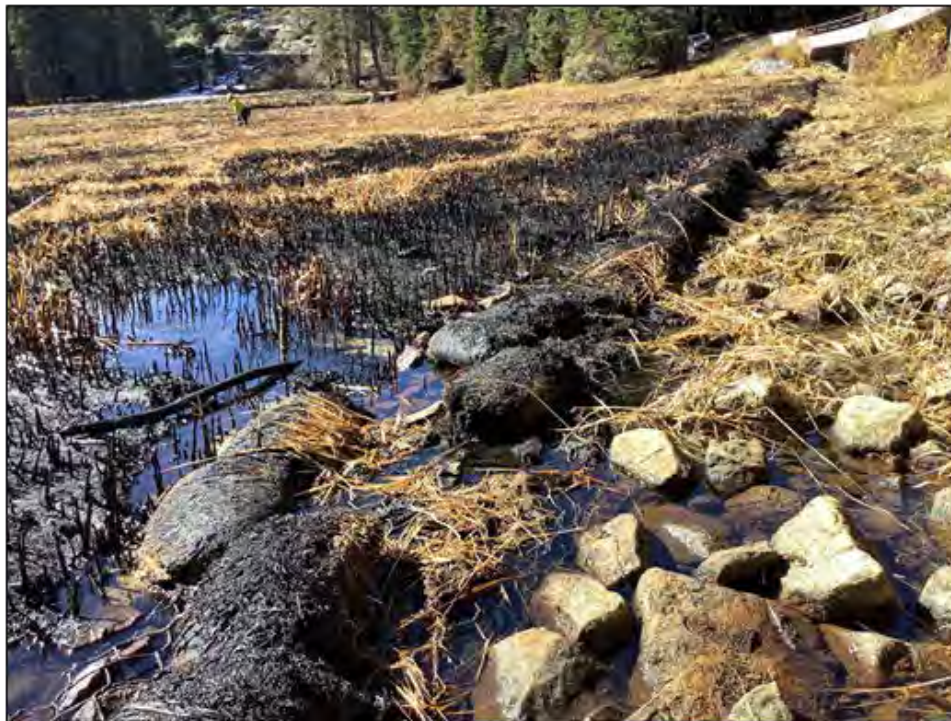
<b>Resource Protection / Revegetation</b>	Fire-damaged sandbags put Halstead Meadow restoration at risk of new gullyng	<b>ES-14:</b> Reinforce damaged sandbags with a row of new ones laid immediately upstream (not on top). Retain damaged sandbags to allow surviving vegetation to colonize new bags
	Areas revegetated for resource protection but damaged by fire suppression activities	<b>BAR-6:</b> Collect propagules, propagate, and install replacement plants in conservation planting areas damaged by fire or those deliberately cut or burned at Giant Forest, Tunnel Rock, and Potwisha Campground.
<b>Native Plant Communities</b>	Ecological degradation by invasive species	<b>ES-13 &amp; BAR-5:</b> Invasive Plant Management: Survey and treat for new infestations of invasive species in sites disturbed by fire suppression activities as well as around known infestations that may have spread into nearby fire-disturbed areas.

**Figure 6.** A row of sandbags designed to spread out surface flow in restored Halstead Meadow was damaged in the KNP Complex and started to fail in the October 25 storm.

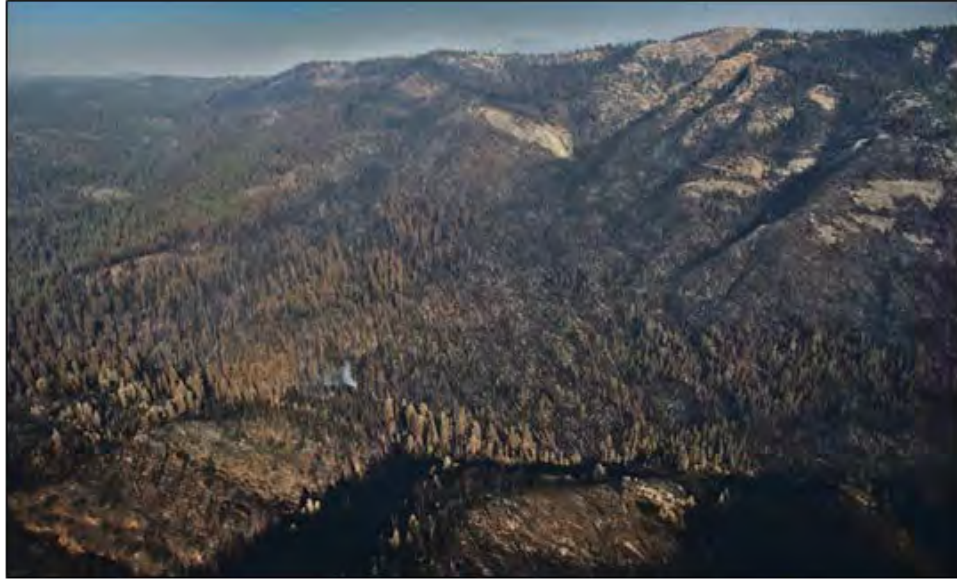
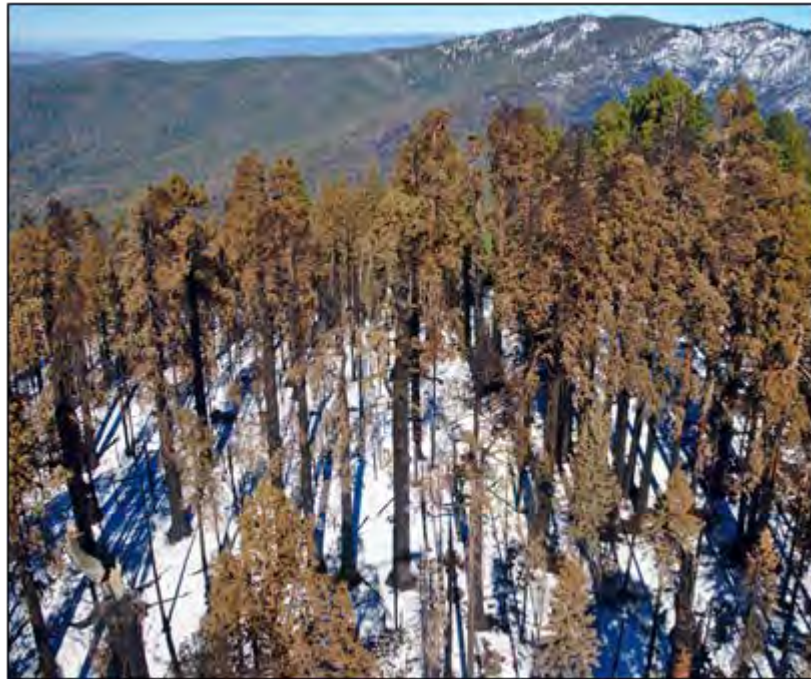
Redwood Mountain Grove had the most substantial acreage impacted by high severity fire (Figure 10a, 10b) followed by Atwell and Suwanee. In the areas in which the Atwell Grove burned severely, the forest was mostly second growth. Reconnaissance via helicopter over the Suwannee Grove indicated that the areas classified as moderate severity were underpredicted in the severity map, potentially resulting in more mortality than expected (Figure 11).

**Figure 10.** Redwood Mountain Grove. Views of (a) top large high severity patch at the southern end of the grove from 10/12/2021 and (b) bottom a close-up view of dead sequoias from 10/27/2021.

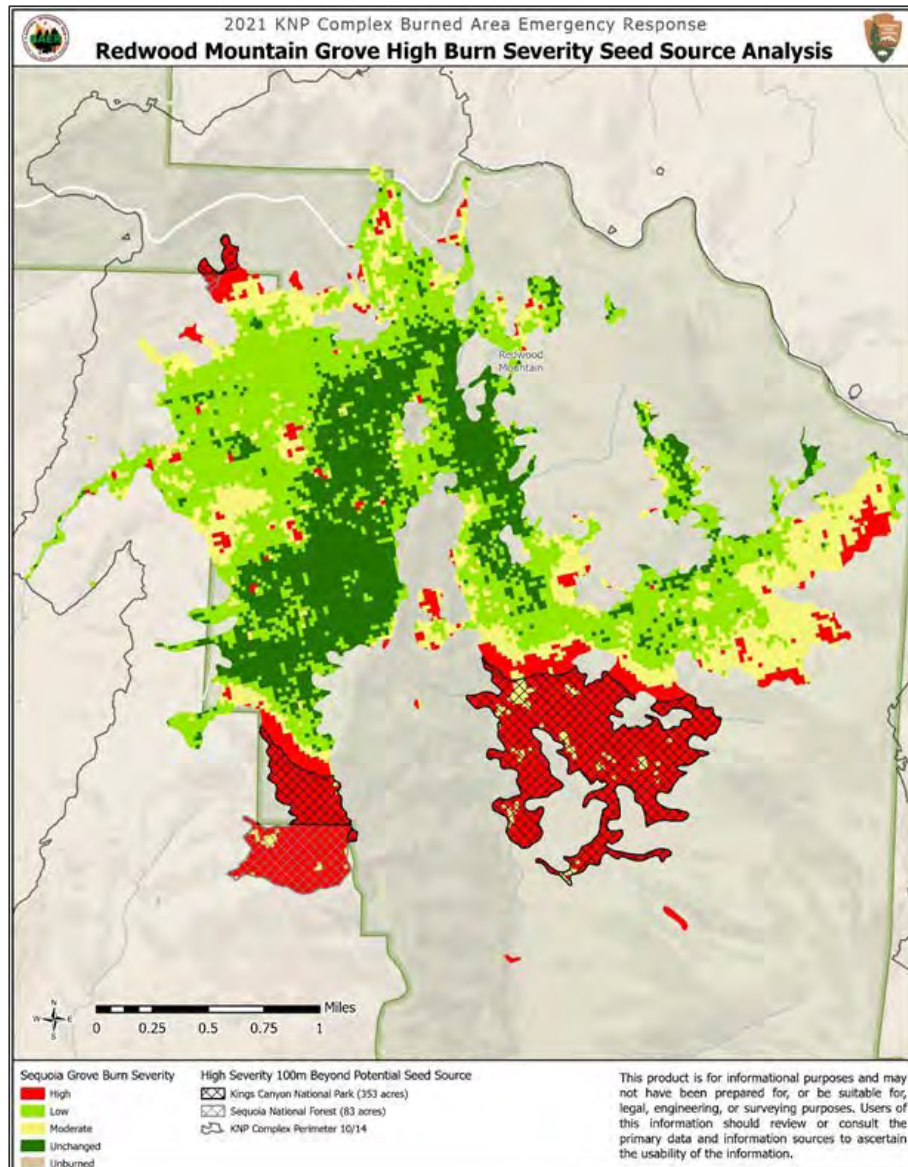
Figure 12. Southern end of Redwood Mountain Grove with significant patches of high severity.

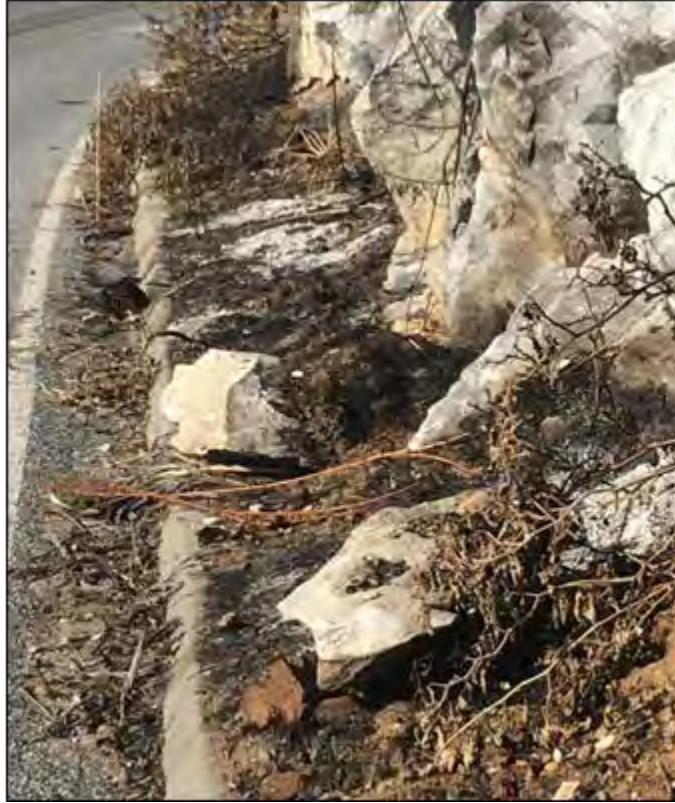
<b>Sensitive Plant Populations</b>	Fire and slope erosion damage to type locality of <i>Eriogonum nudum</i> var. <i>murinum</i>	<b>BAR-8:</b> Propagate and out-plant 50 plugs of this species from seed collected in the type locality, to replace those burnt or buried during the fire.
<b>Vegetation Monitoring Plots</b>	Plot monumentation damaged; potential that plots no longer are valid for monitoring goals	<b>Non-Specification Recommendation:</b> Inspect plots within burn footprint, replace damaged plot stakes and tags, decommission plots and/or select new monitoring plots if needed.

**Figure 14.** Type locality of mouse buckwheat, showing the impact of fire and rock/soil movement. Approximately 20 plants were lost at this location.

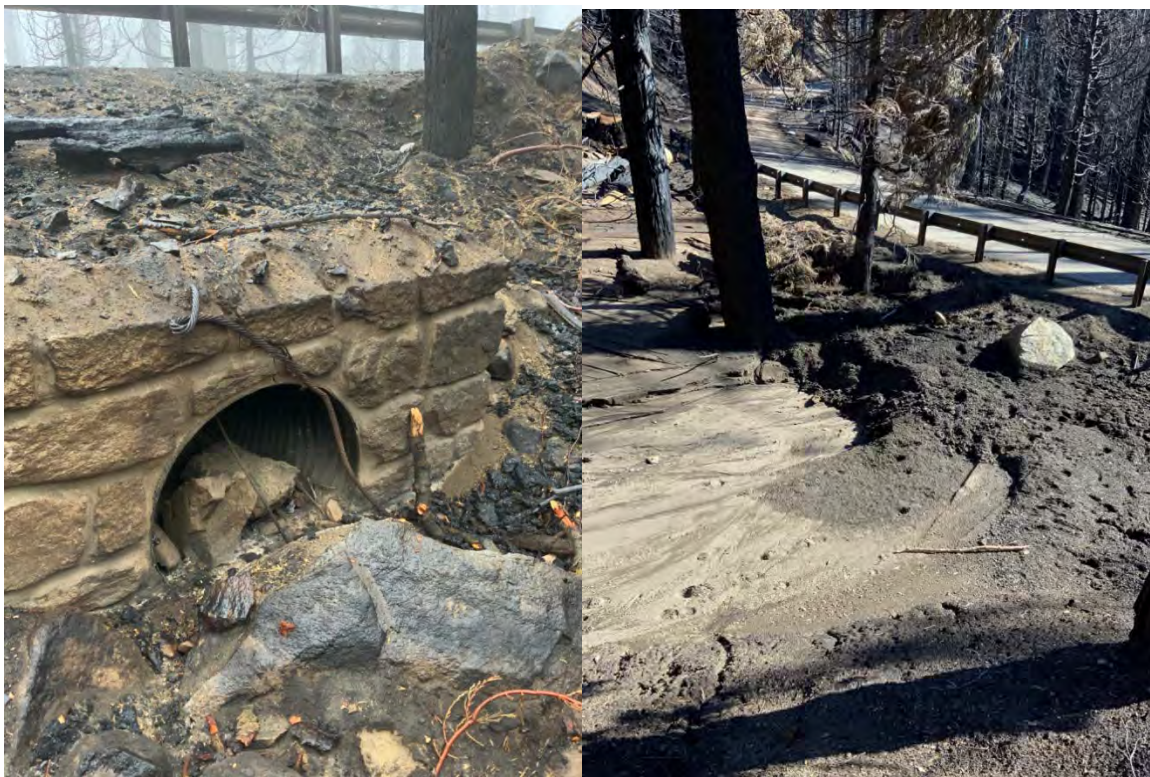
Figure 1. A culvert up the road from Red Fir Maintenance facility before and after the Oct 25 storm

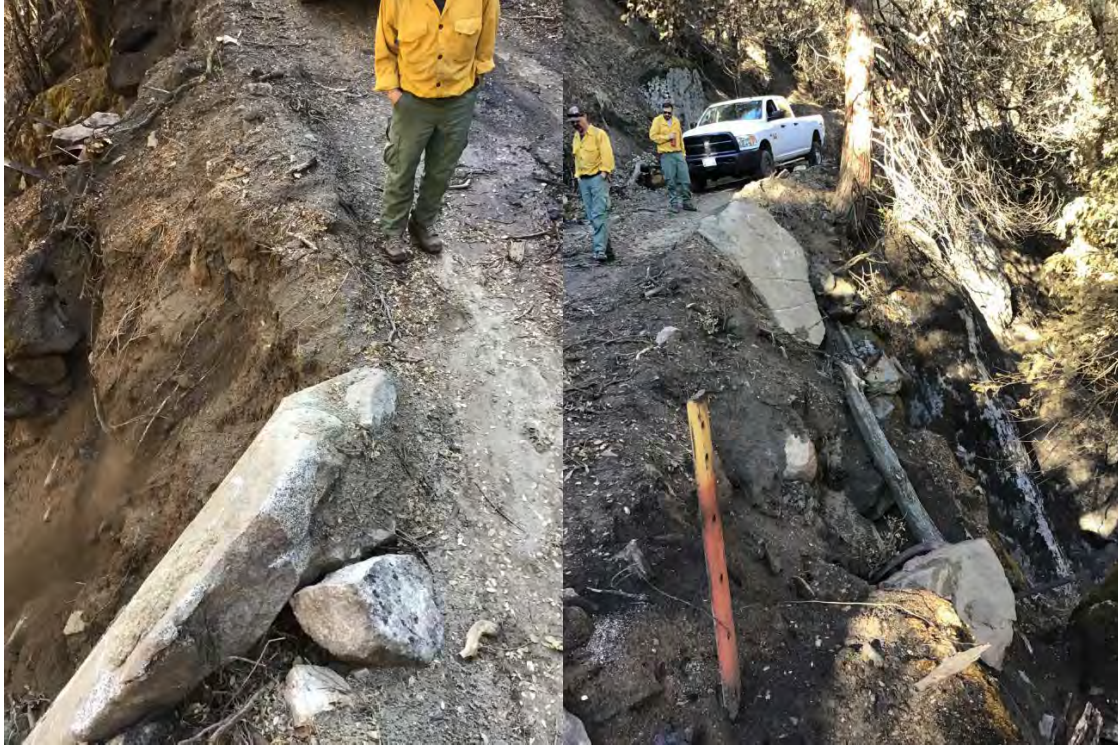
Figure 2. Oriole Lake road retaining structure lost

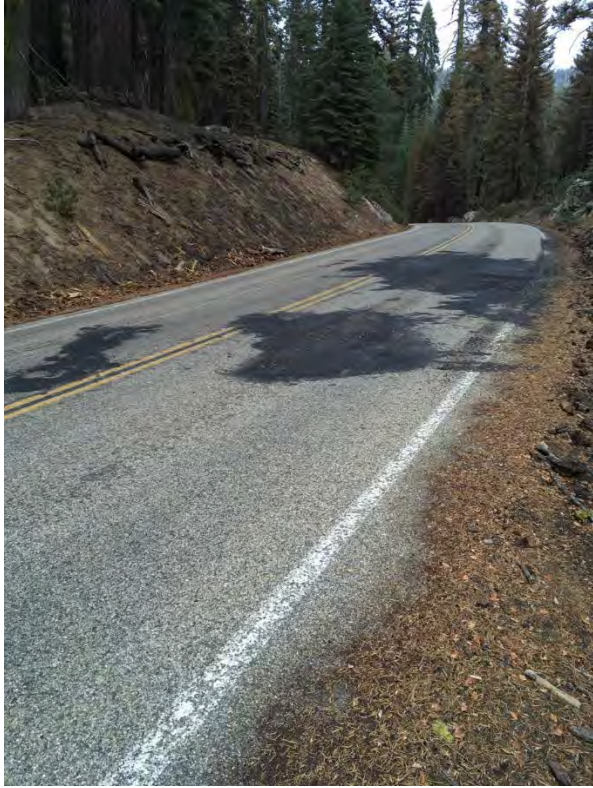
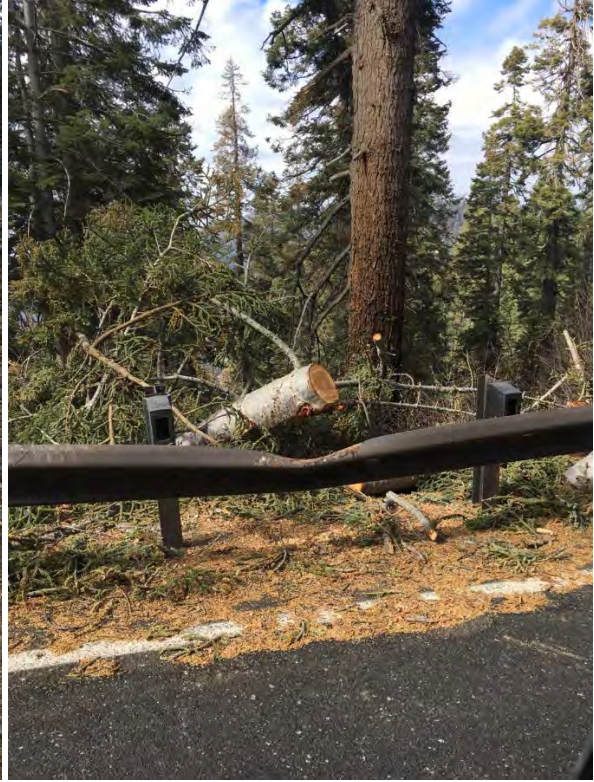
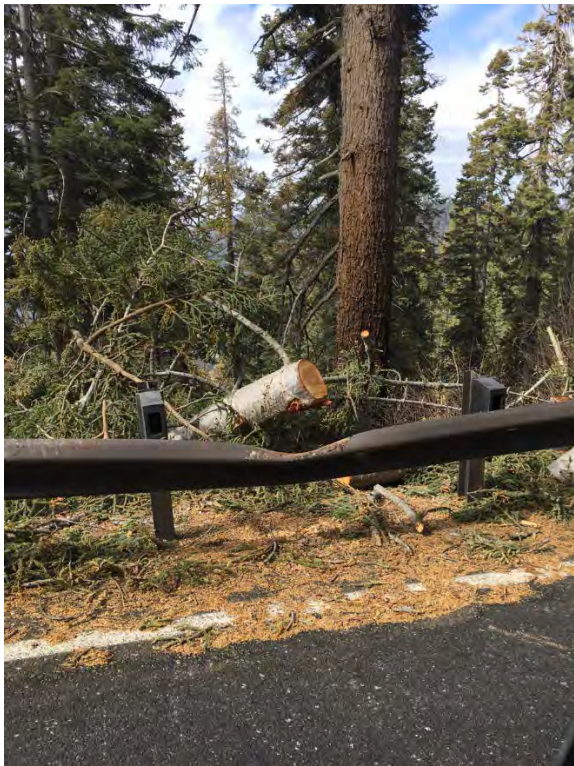
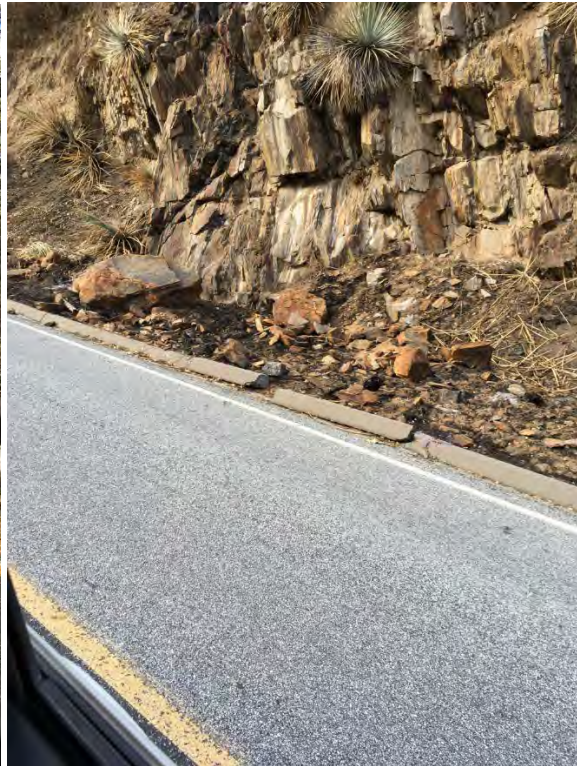
Figure 3. Road damage on Generals Highway

Road Hazard Signs	Signage to inform drivers of post-fire hazardous roadway conditions	<b>ES-6:</b> Install signs.
Storm Patrol	Rolling rocks, debris and falling trees will block the road causing a driving hazard	<b>ES-2:</b> Clear roads of debris.
Road Damage	Falling trees and burning trees have damaged segments of road surface. Burned geotextile fabric may have destabilized road foundation	<b>ES-4:</b> Repair road surface, contract geotextile analyses.

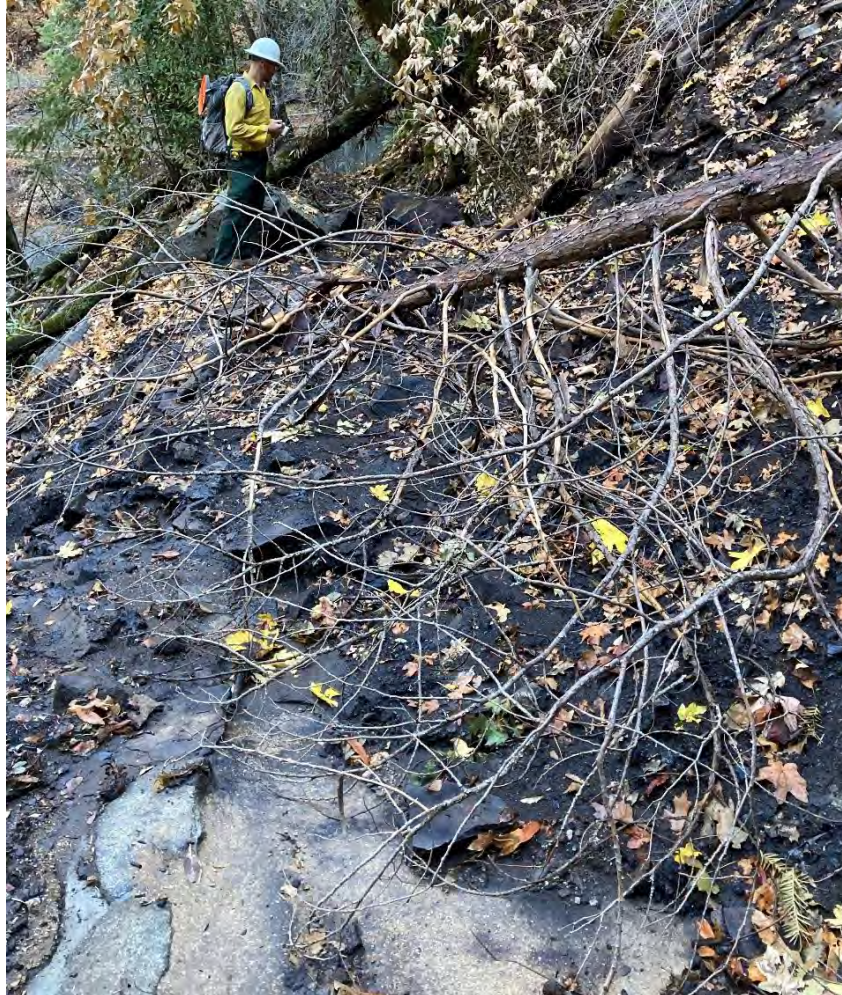
*Figure 1. Soil and woody debris on Crystal Cave trail.*

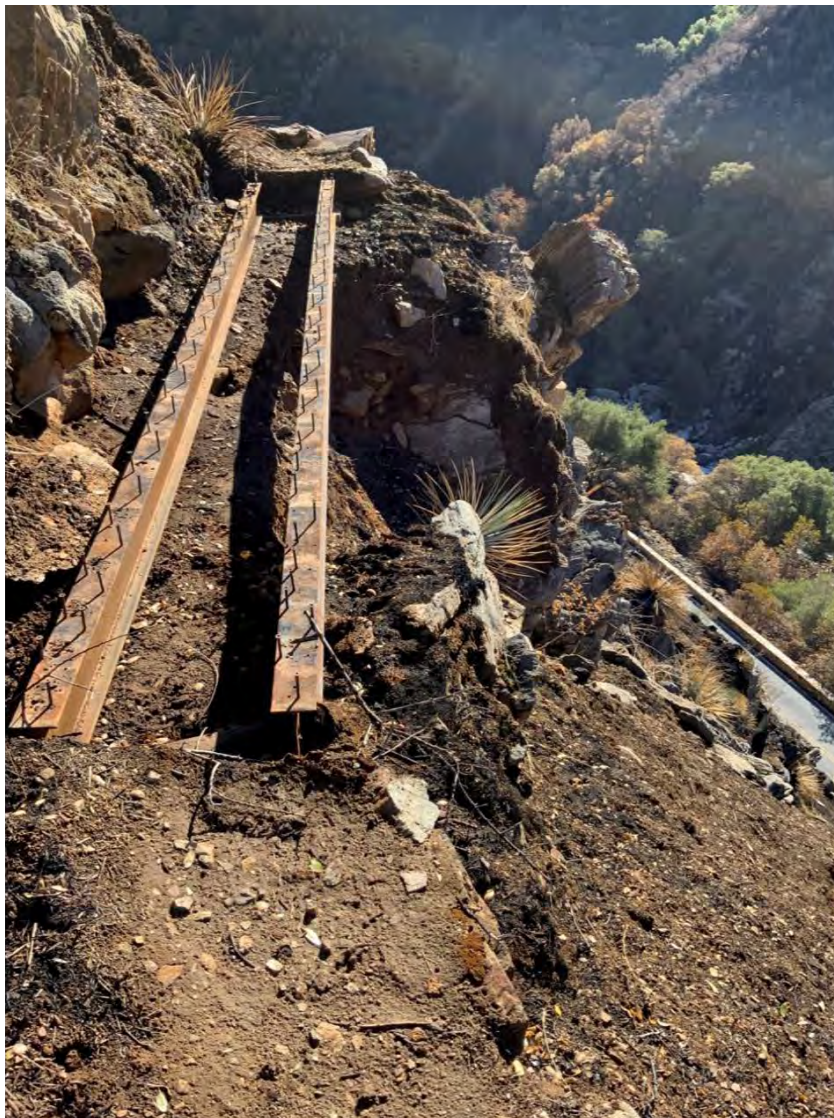
*Figure 2. Burned boardwalk, Hospital Rock-Potwisha trail.*

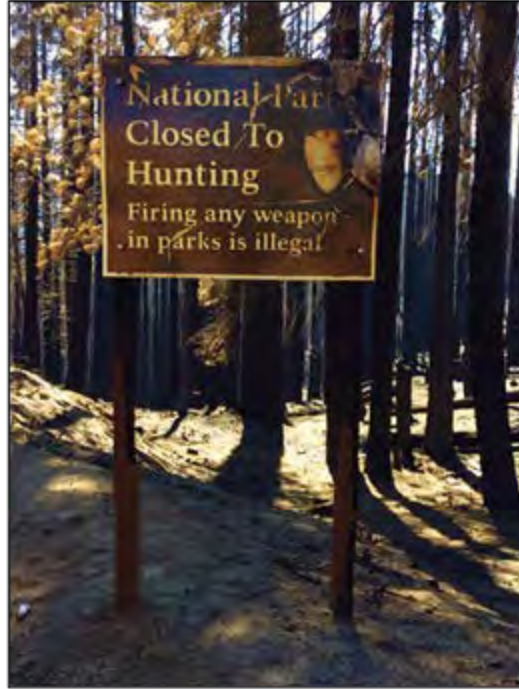
Burned NPS Regulatory Sign

Topic/Issue	Roads	
<b>Background</b>		
<p>The General's Highway and Mineral King Road were impacted directly by the KNP Complex and will sustain further damage due to post-fire events. Directional highway signs have burned, a bridge has burned, and asphalt road surfaces have been damaged by burning vegetation, heat, and falling trees. Road culverts will continue to fill with debris and sediment. Recommended actions include clearing storm debris from the road and placing fire hazard and closure signs to inform drivers of hazards.</p>		
VAR	Issue(s)/Concern(s)	Potential Response(s)
General's Highway Culverts	Rolling debris and sediment can clog the inlet to culverts causing them to fail during storm events	<b>ES-2:</b> Clean culverts after storms.
Mineral King Road Culverts	Stationary targets / vehicles	<b>ES-2:</b> Clean culverts after storms.
Road Statute signs	Signage to inform drivers of road conditions to enable safe driving (curves in road, safe driving speeds, etc.)	<b>ES-6:</b> Replace signs.

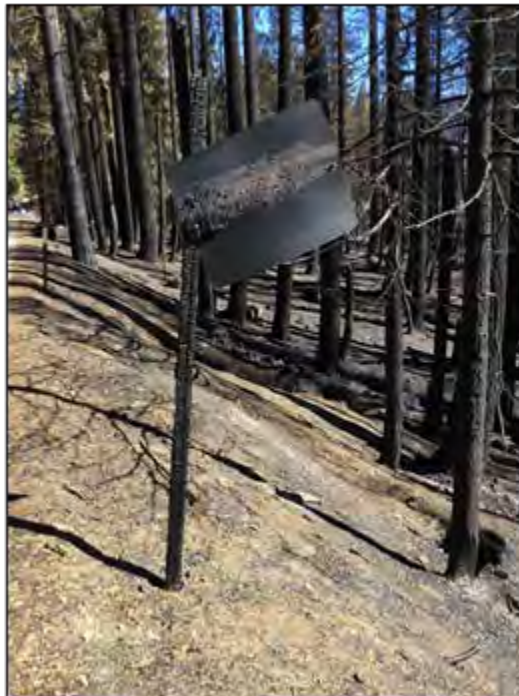
Burned Speed Limit Sign

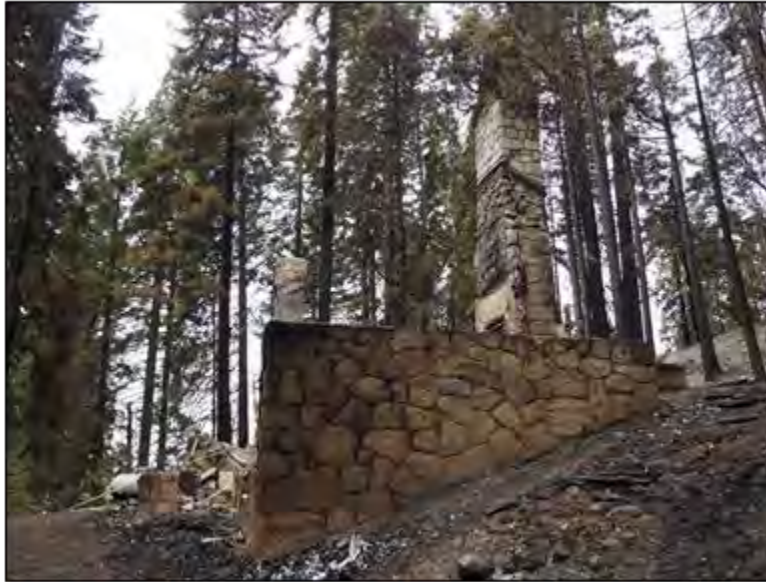
VAR	Issue(s)/Concern(s)	Potential Response(s)
<p><b>Historic Structures</b></p>	<p>Redwood Mountain Ranger Station was destroyed by fire on 10/4/21. Issues include debris and HAZMAT stabilization, feature stabilization, and exclusionary measures for public safety. Redwood Mountain Equipment Garage was not damaged by fire, but hazard trees are a concern.</p>	<p><b>ES-1: Hazard Tree Assessment &amp; Mitigation</b> Addresses the removal of hazard trees threatening this building. Directionally fall hazard trees away from structures. No further assessments needed.</p> <p><b>ES-9: Cultural Protection and Stabilization</b> Exclusionary measures to secure site from uncontrolled access for safety, looting, and vandalism.</p>
	<p>Barton's Log/Croser's Cabin was destroyed by fire on October 4, 2021. There is a concern for vandalism and looting.</p>	<p><b>ES-9: Cultural Protection and Stabilization</b> addresses looting and vandalism concerns by increasing park presence to monitor the site. The interpretive sign indicating to visitors the presence of a cabin site should be removed.</p>

*Photo 1 Redwood Mountain Ranger Station masonry remnants. View looking west.*

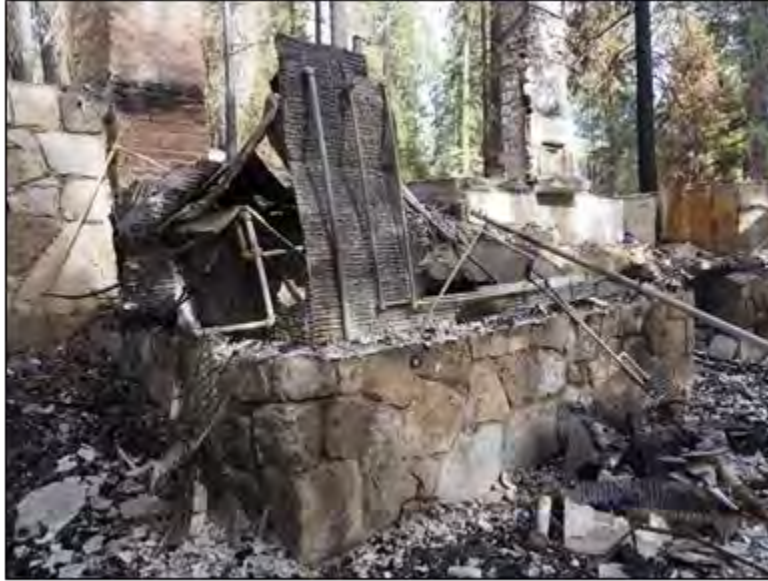
*Photo 2 Redwood Mountain Ranger Station masonry remnants. View looking northeast.*

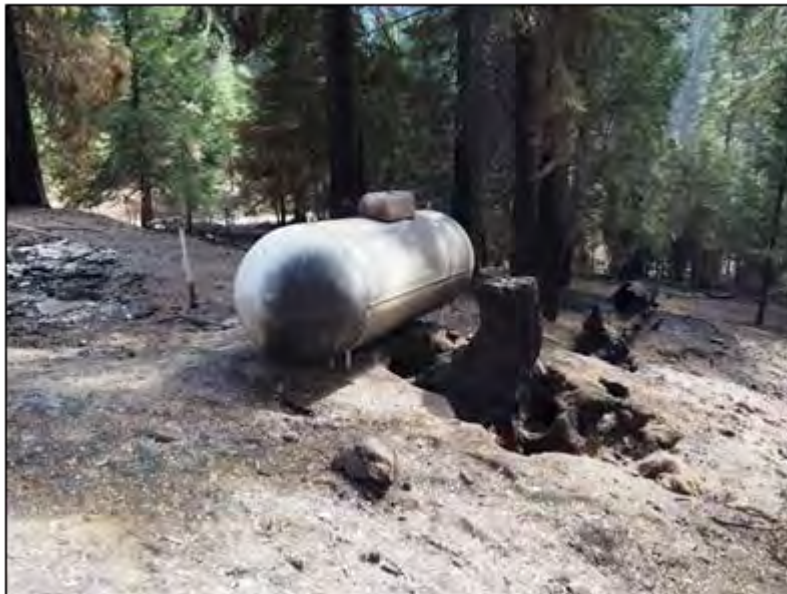
*Photo 3 Redwood Mountain Ranger Station propane tank. View looking southeast.*

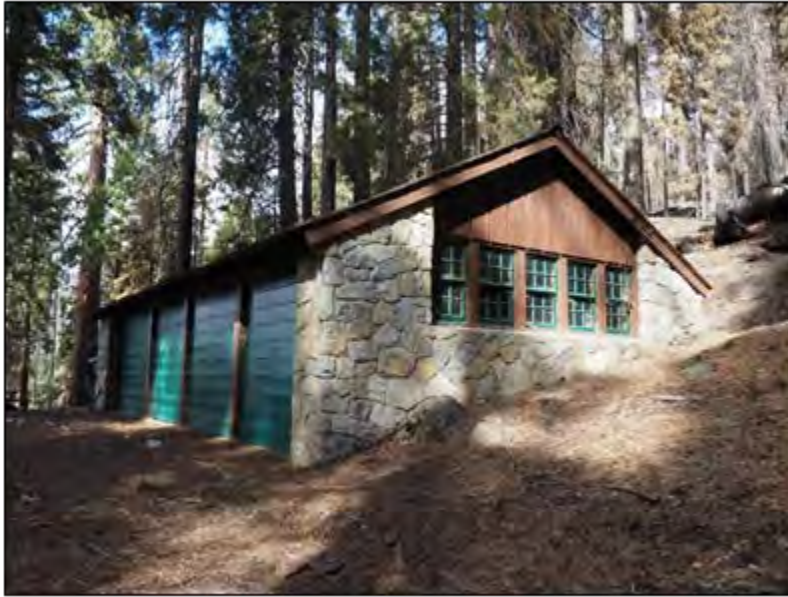
*Photo 4 Redwood Mountain Garage/Equipment Shed. View looking west.*

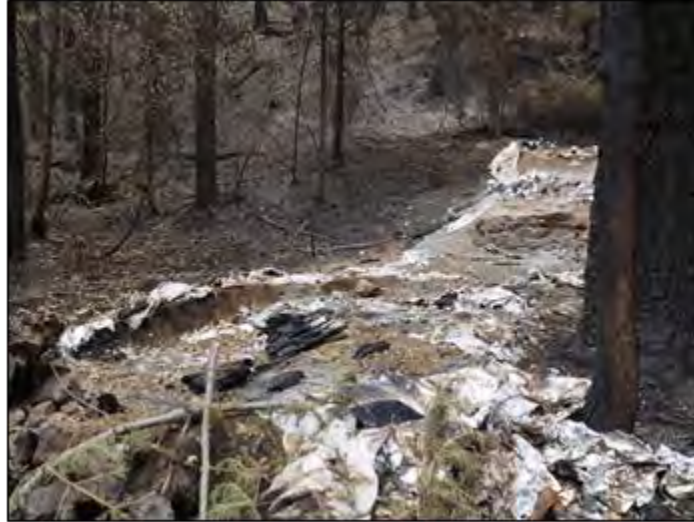
*Photo 5 Barton's Log/Crose's Cabin remains. View looking north.*

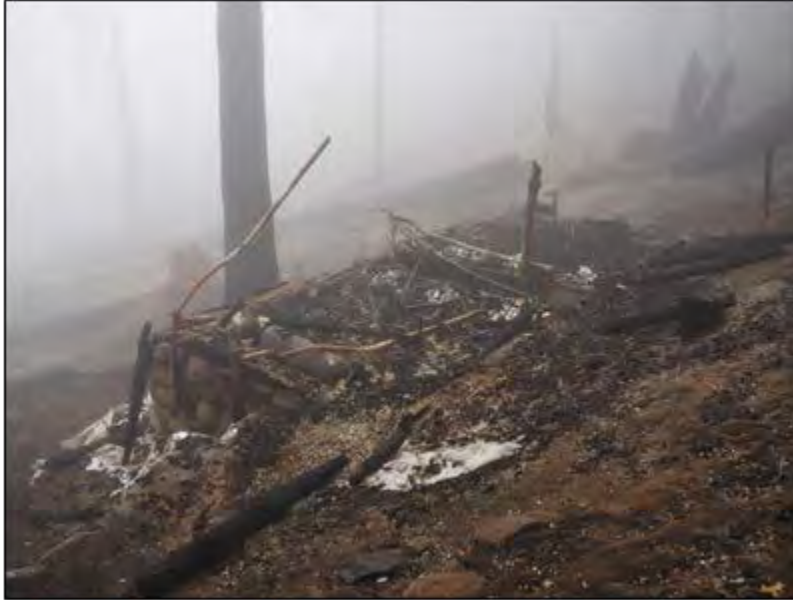
*Photo 6 Moro Rock Comfort Station remains. View looking west.*

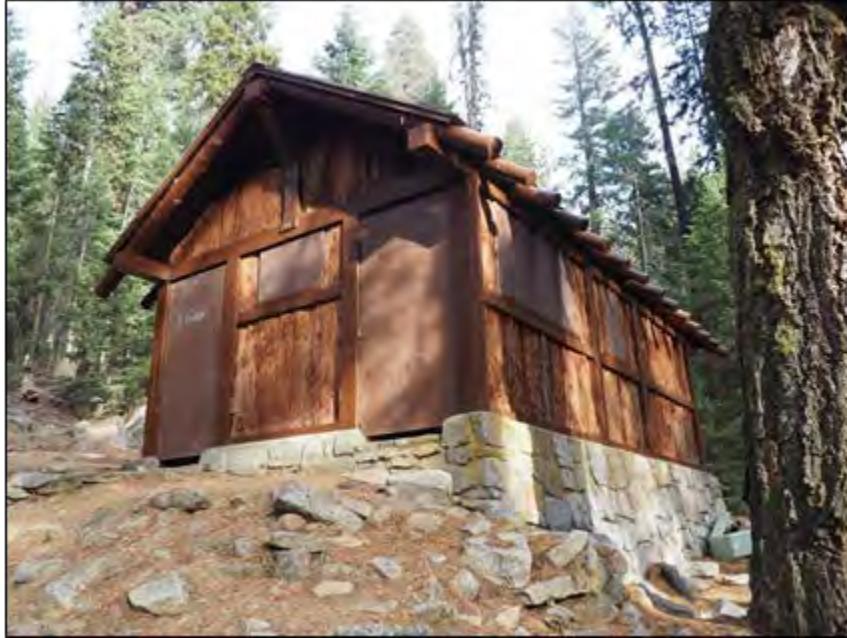
The Lost Grove Comfort Station was not damaged by fire, but hazard trees are a concern.	<b>ES-1: Hazard Tree Assessment &amp; Mitigation</b> Addresses the removal of hazard trees threatening these buildings. Directionally fall hazard trees away
--	-----------------------------------------------------------------------------------------	--------------------------------------------------------------------------------------------------------------------------------------------------------------

*Photo 8 Lost Grove Comfort Station. View looking upslope, east.*

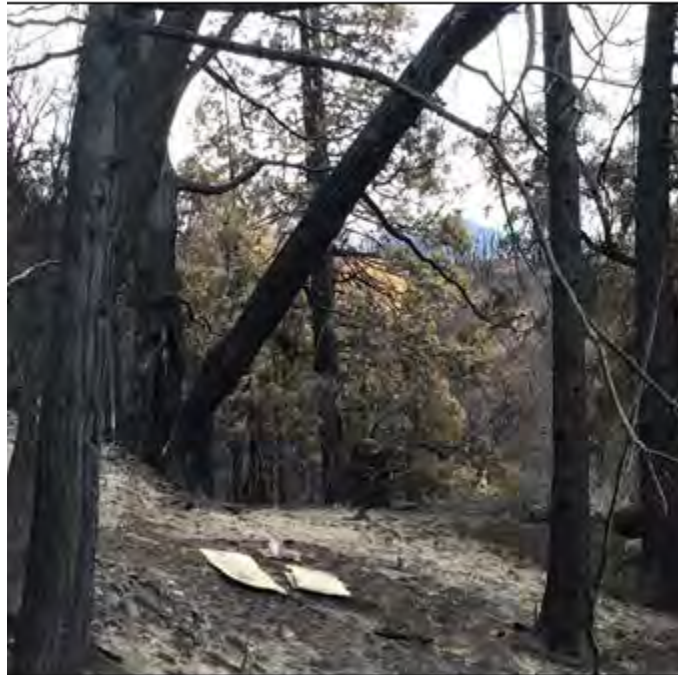
*Photo 18. Example of a hazard tree hanging over a historic stone fireplace feature at (CA-TUL-2235H). If the tree is still standing after reassessment in FY22, then it should be removed to prevent potential damage to the feature and surrounding artifacts.*

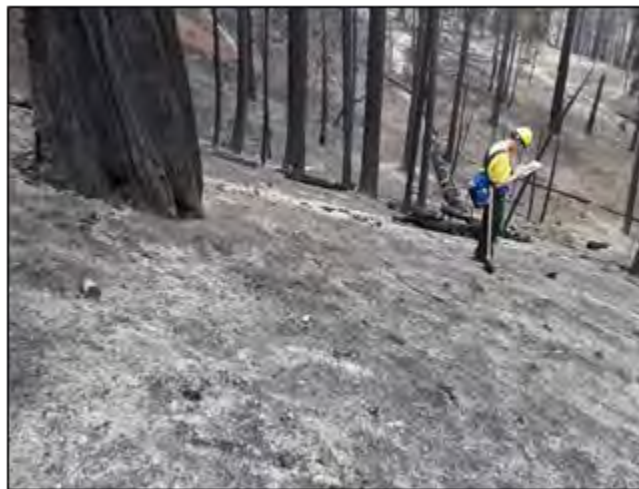
Photo 19. Example of exposed historic artifacts eroding downslope in burn area at CA-TUL-3183H. BAER Archaeologist Weston Bacon-Schulte pictured.

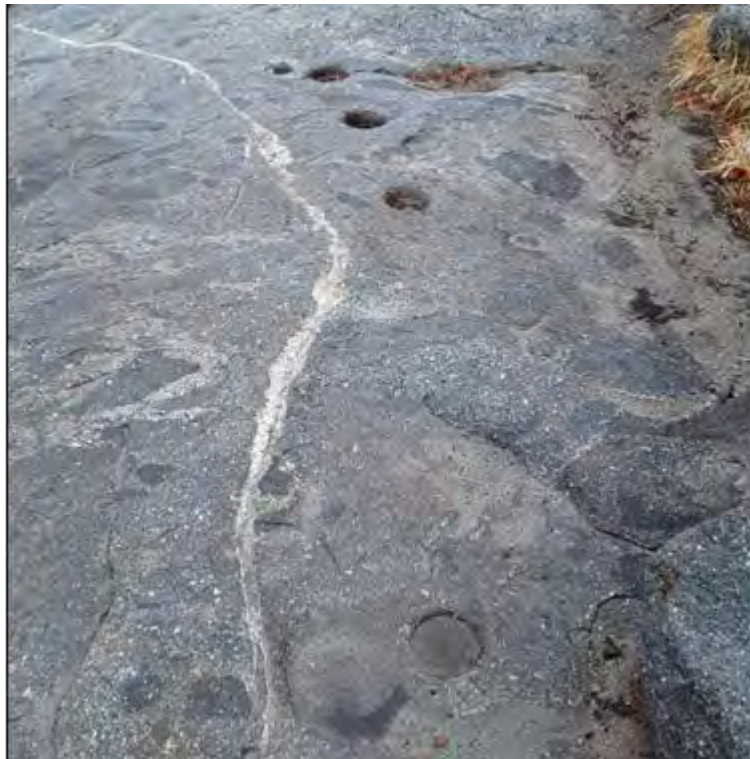
*Photo 20. Example of significant cultural and archaeological site near (CA-TUL-0028) within the KNP Complex perimeter in SEKI. Portions of the site burned, but the areas around the pictograph and bedrock mortar features at the site were not directly damaged.*
